## **International SAICM Implementation Project (ISIP)**

**Title of activity:** Mapping toxics in surrounding of Phuket as a contribution to global debate about POPs in wastes

**NGO:** Ecological Alert and Recovery – Thailand (EARTH)

**Date:** August 2011

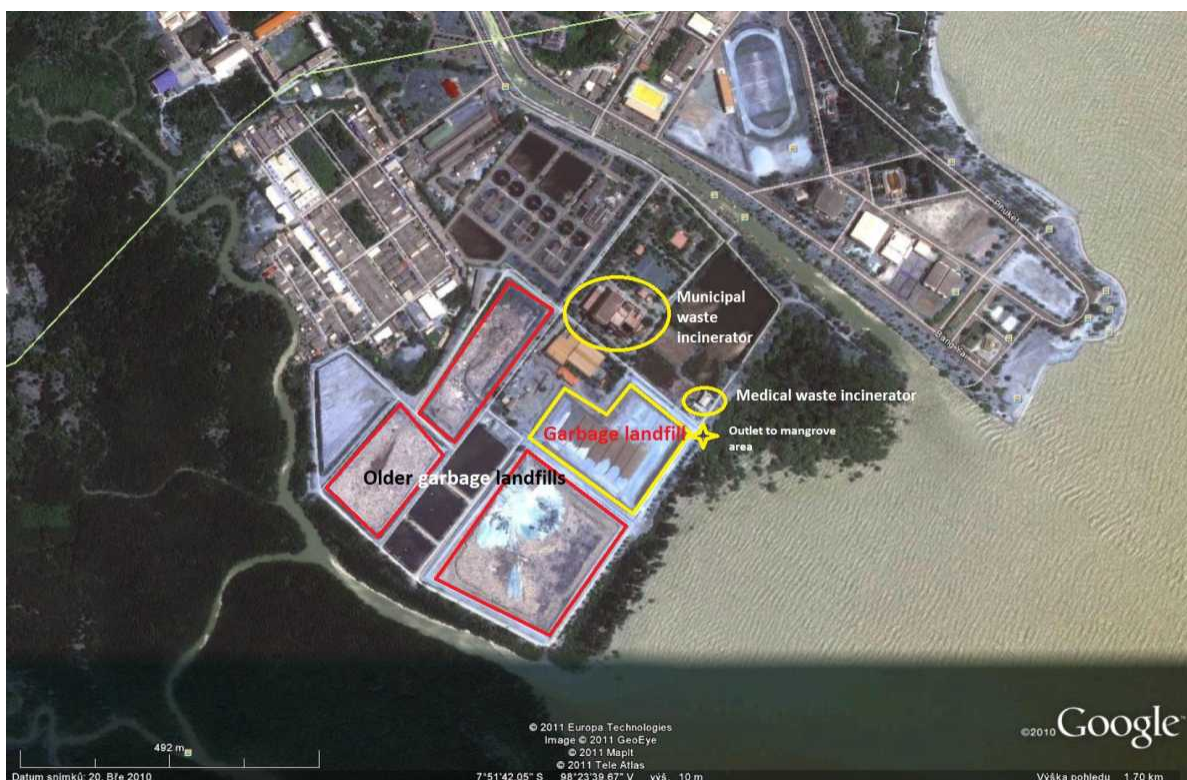
Picture 1:

The Phuket landfill/incinerator complex is located along side the BangYai canal downstream from the city and close to its confluence with the sea. The whole complex was built in a mangrove wetland. More detailed information about the situation can be seen in the map below.

Arnika Association (led by Jindrich Petrlik) from Czech Republic and the team of EARTH (Ecological Alert and Recovery - Thailand) led by Penchom Saetang, Walaiporn Mooksuwan and Arpa Wangkeit sampled ashes, sediment and biota in the surrounding area of the Phuket waste incinerators in December, 2010. On 10<sup>th</sup> December we went to look at the site and to interview local fishermen as well as other local residents and to see potential sampling sites. On 11<sup>th</sup> December we took samples of what we thought was a mixture of fly ash and bottom ash, according its consistency. We also took samples of sediments in the mangrove area near the outlet from the waste management complex area (see the star sign at map on Picture 1).

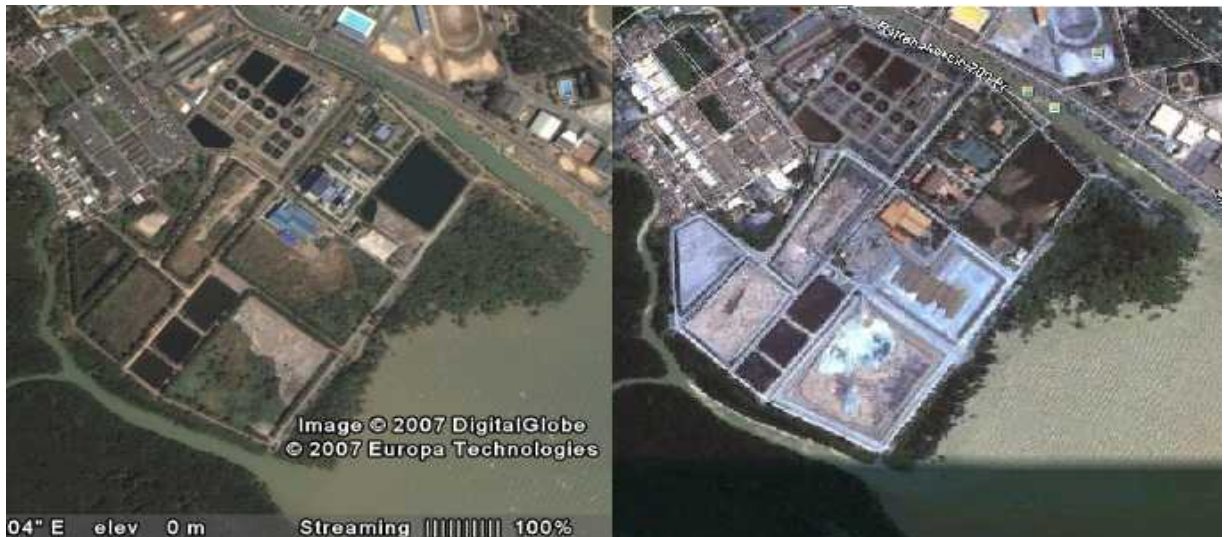
The waste incinerator in Phuket sends fly ash for specific land-filling. According to the Greenpeace report (Labunska, Stephenson et al. 2000), there has been land-filling next to the waste incinerator (together with bottom ash) for a long time. Fly ash was found by a Swedish scientist during his sampling in 2009 in the area close to waste incinerator (UU 2009). At least part of the landfill with fly ash was most likely removed during the construction of the new waste incinerator. By comparing a current photomap from Google Earth with another one from 2007, one can see that the area has changed during the years (see Picture 2).

Picture 2: By comparing the photomap from 2007 (left side) with that from 2010 (right side), it becomes clear that land use has changed around the waste incinerator in Phuket. The large grey area at the south east edge of the incinerator was an area filled with fly ash dumping in 2007.

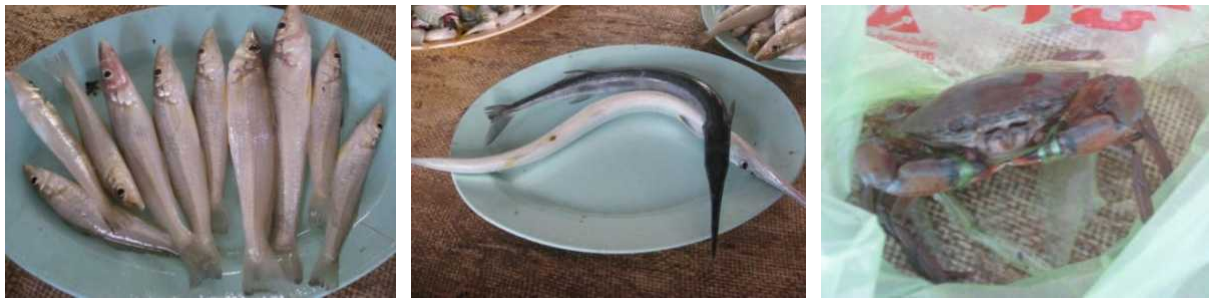
Local fishermen caught some crabs and fish at two sites in the sea bay near the waste complex area. They are marked in the map at Picture 3: 1) bay east from canal (approx 800 m from the shore) and 2) bay near mangrove (approx 500 m from mangrove). Local residents, who used to

pick food in the mangrove area, provided us with samples of shellfish, crabs and fish from two other sites: 3) mangrove area next to the waste complex and 4) river mouth south from the waste complex. Two days later local residents also picked samples of two bird eggs. They did not recognize which species the birds were, but most likely some passerine birds.

Picture 3: Map showing sampling sites in Phuket at Google Earth map. Both waste incinerators and eggs sampling area are marked by pins sign, other sampling areas are marked by red lines with their names in yellow, black and white letters.
