Mercury Contaminated Sites - Chemical Industry Legacy in CEE Region

*Jindrich Petrlík - IPEN Toxic Metals WG co-
chair*

Mercury Contaminated Sites in CEE Region

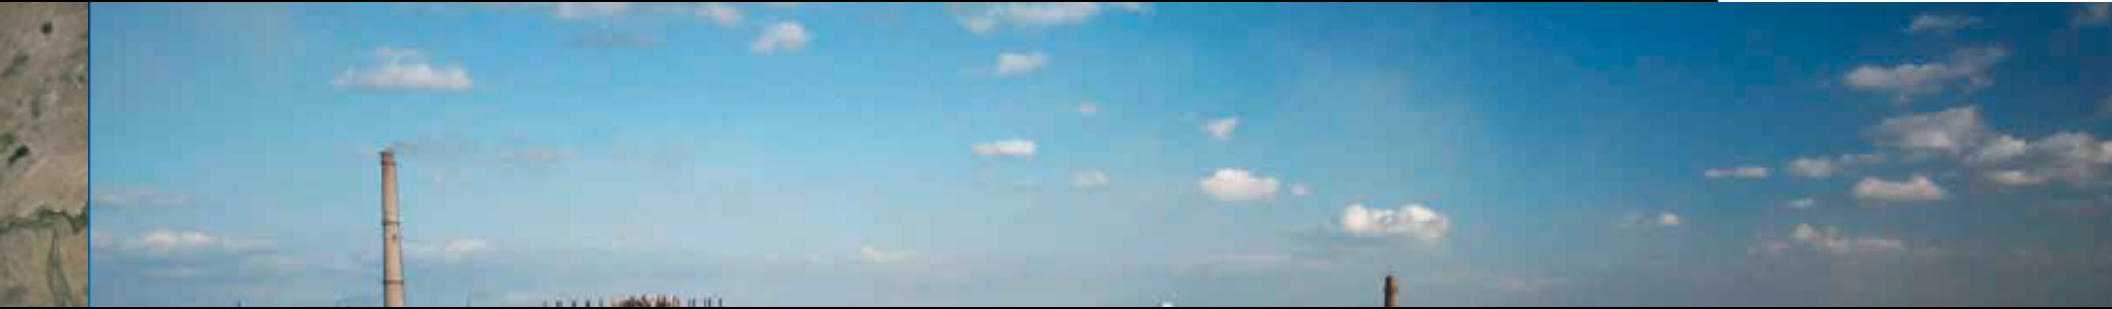
Nura river, „Karbid“ Temirtau (Kazakhstan)

ANALYSIS OF HUMAN HEALTH RISKS ASSOCIATED WITH MERCURY IN SELECTED SAMPLES – HAZARD QUOTIENTS (HQ).

Concentration in soil (mg kg ⁻¹)	Exposition pathway			
	Ingestion of soil	Dermal contact of soil	Ingestion of vegetable	
11.8	8.4E-02	1.7E-02	3.5E+00	3.6E+00
10.1	7.2E-02	1.4E-02	3.0E+00	3.1E+00
17.0	1.2E-01	2.4E-02	5.1E+00	5.2E+00
178	1.3E+00	2.5E-01	5.3E+01	5.5E+01
10.8	7.7E-02	1.5E-02	3.2E+00	3.3E+00

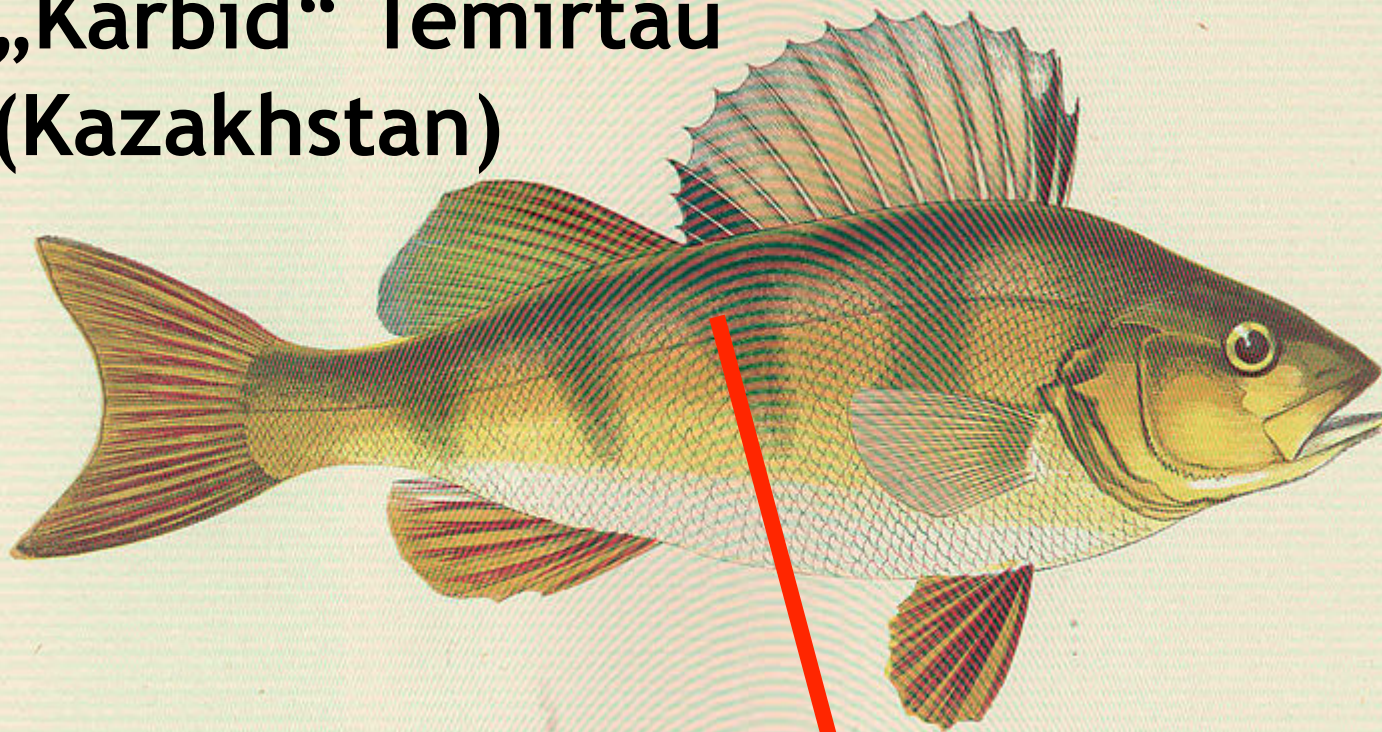
Nura river, „Karbid“ Temirtau (Kazakhstan)

MERCURY IN
S GIVEN IN

Standard deviation (SD) of the measurement is 12 %.

Sample Code	Mercury (mg kg ⁻¹)	Methylmercury (mg kg ⁻¹)
NUR-F-14/1/1	0.442	0.343
NUR-F-14/1/2-3	1.38	1.36
NUR-F-14/2	0.634	0.543

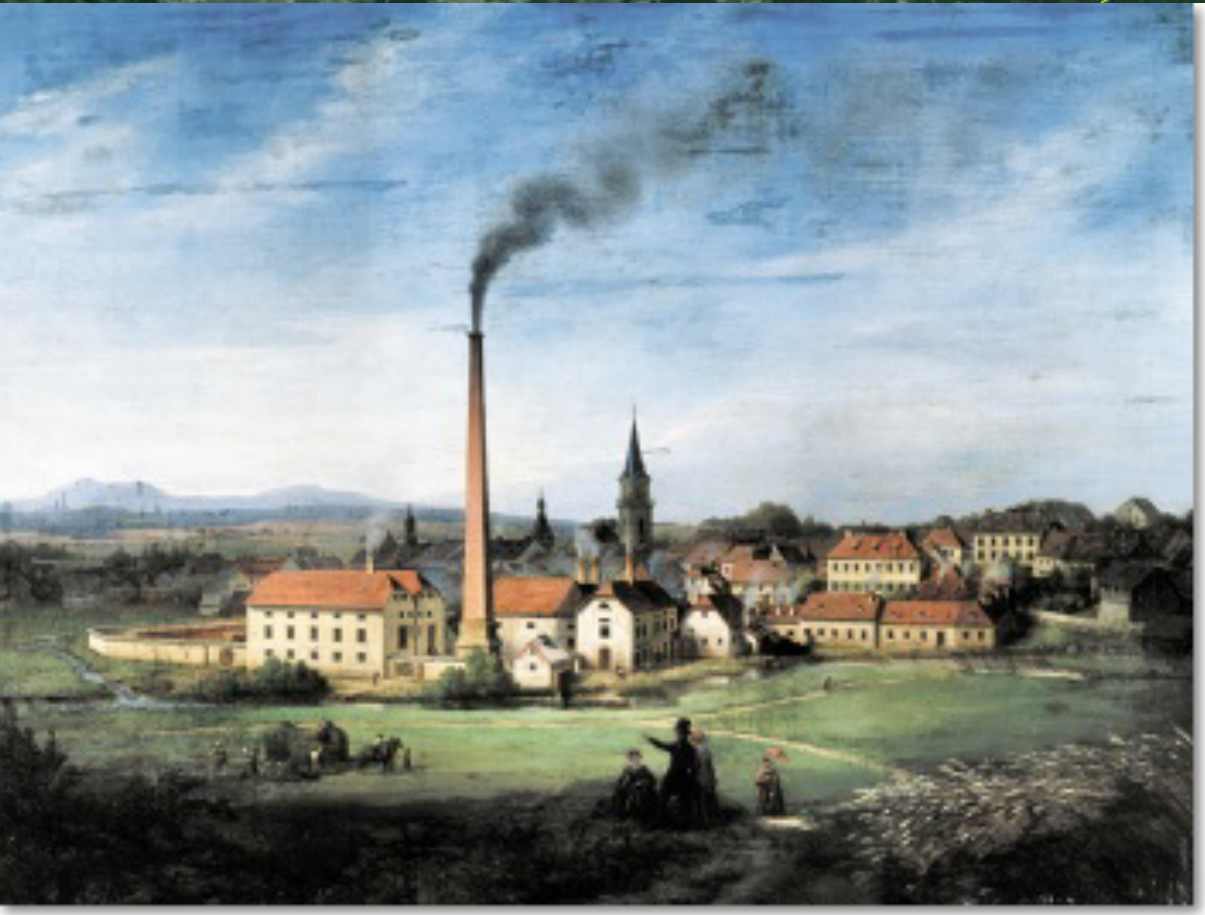
Martredwitz (Germany) and Skalka reservoir (Czech Rep.)

Established in 1788; 1907 – 1985 – herbicide production based on mercury

by mercury can be several tenths km far downstream from the plant (e.g. Karbid facility 60 - 70 km far from Intumak dam (Kazakhstan); Marktredwitz, Germany 20 km from Skalka dam, Czech Republic)
