## The International POPs Elimination Project (IPEP)

### Hotspot report for a Contaminated Site:

### Old Korogwe DDT Site in Tanzania

May 2005

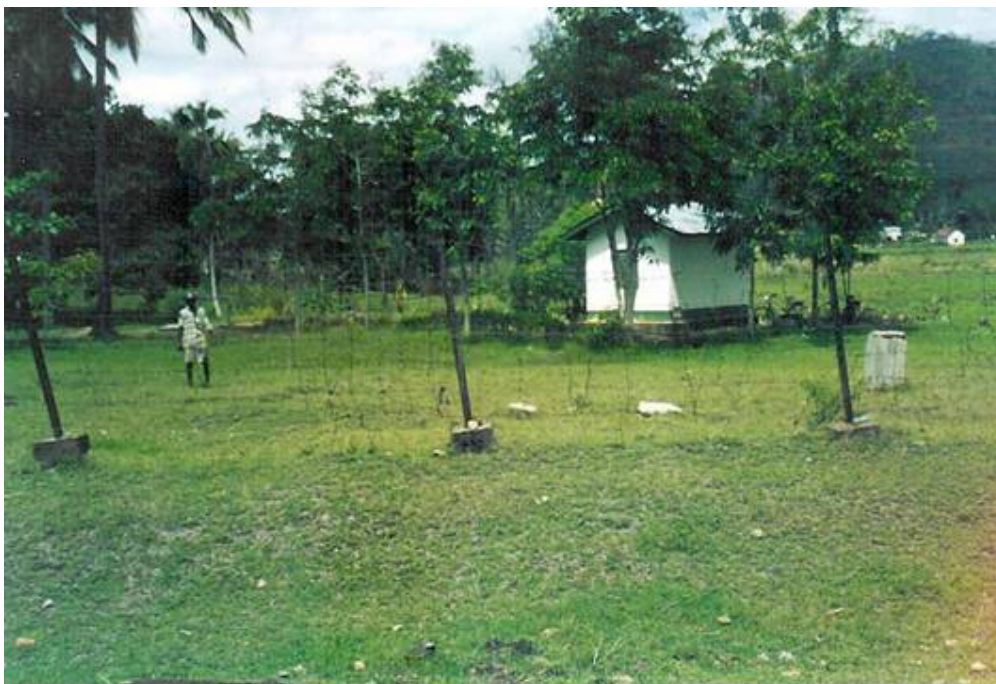
**Fig. 3 Main water supply pump at a white-painted building within 50 meters from the pesticides storage facility**

The Old Korogwe Village is drained by tributaries of the Pangani River which also serve the community water for washing, gardening, irrigation, fishing and drinking water for livestock. The Pangani River pours its water into the Indian Ocean. The Pangani River is important for paddy production. Within 50 meters (North) from the contaminated site (storage facility), there is a water pump and a deep-well (180 ft deep borehole) as shown in Fig. 2, which is the only source of drinking water for the entire Old Korogwe population. The quality of water from the deep well near the contaminated site is not known.

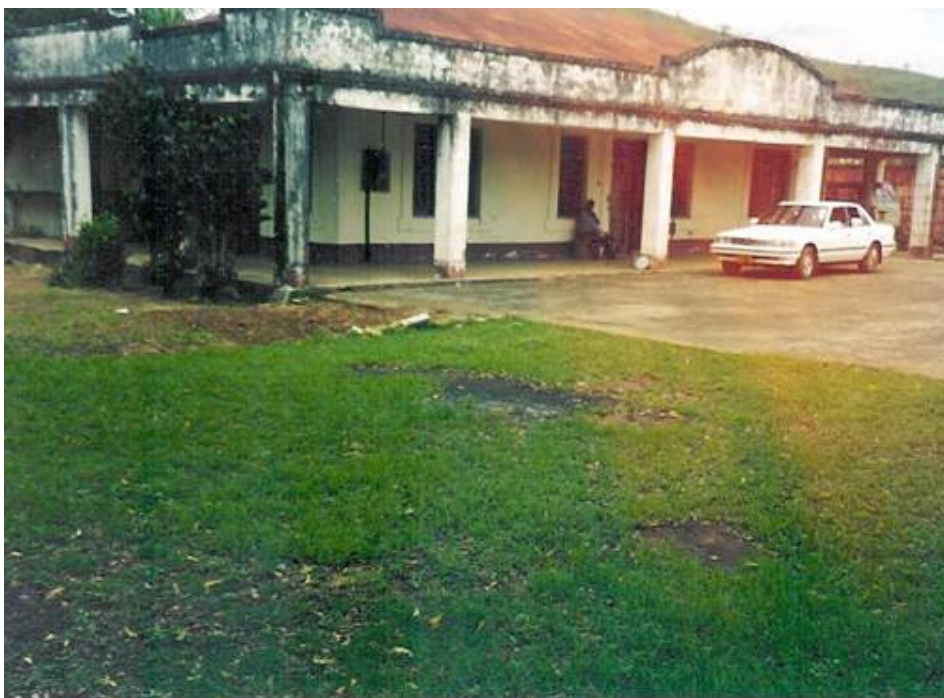
Most of the buildings near the site area have been demolished. However, there is one building which is used as an office for CREW (Credit for Women) activities. The CREW activities include amongst others; conducting seminar to credit applicants who are female, meetings and Office business. The office building (see Fig. 3) is within about 10 meters from the DDT storage shed.

**Fig. 4** Building used as CREW office within about 10 m from the pesticides store on the left side

Although the shelter was slightly improved by NEMC in 2003 by half-fixing the store sides with corrugated iron sheets, the top part was left open to air. The smell of DDT at the nearby area and the CREW Office indicates that the present shelter does not prevent dispersion of dust by wind and also vaporization. The community leaders and the District Authority are also concerned about the contamination of the natural environment in agricultural processes and to the presence of pesticides residues in food to be eaten by humans. Although these concerns could not be substantiated, accumulated worries as a result of pesticides could lead to social unrest by community members.

While the buildings near the site area have been demolished, there is no immediate reuse of the land. It seems that the plot could be declared useless or abandoned. The Manager of CREW expressed concern for embarrassment she experiences when the smell is so intense while she is with customers, visitors or seminar participants.

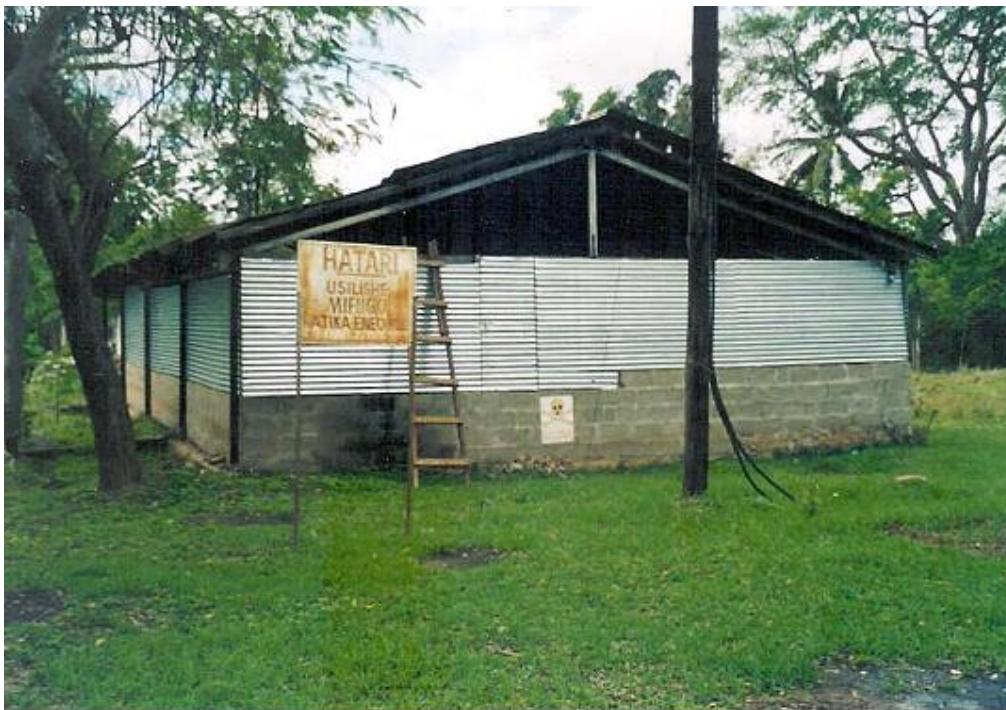
The stockpiles of DDT pesticides at Old Korogwe site is owned by the Ministry of Agriculture and Food Security. The piles of obsolete pesticides used to be in an open shed until November 2003 when the store was improved with corrugated iron sheets. However, the current storage status is

still very poor since the package bags have been worn out leaving the bulk of DDT powder vulnerable to wind uptake.

**Fig. 5** The new storage facility at Old Korogwe

The old storage facility was generally poorly constructed as it was an open air construction. In 1999 a shelter was constructed by NEMC to prevent draining of chemicals during rain season. The store however was still an air open shed which could not prevent the uptake of DDT powder by blowing wind into nearby Pangani River tributary and the surrounding environment. The shelter was slightly improved by NEMC in 2003 by half-fixing the store sides with corrugated iron sheets, leaving that top half open to air as can be seen in Fig. 4. The smell of DDT at the nearby area indicates that the present shelter does not prevent dispersion of dust by wind and also vaporization.

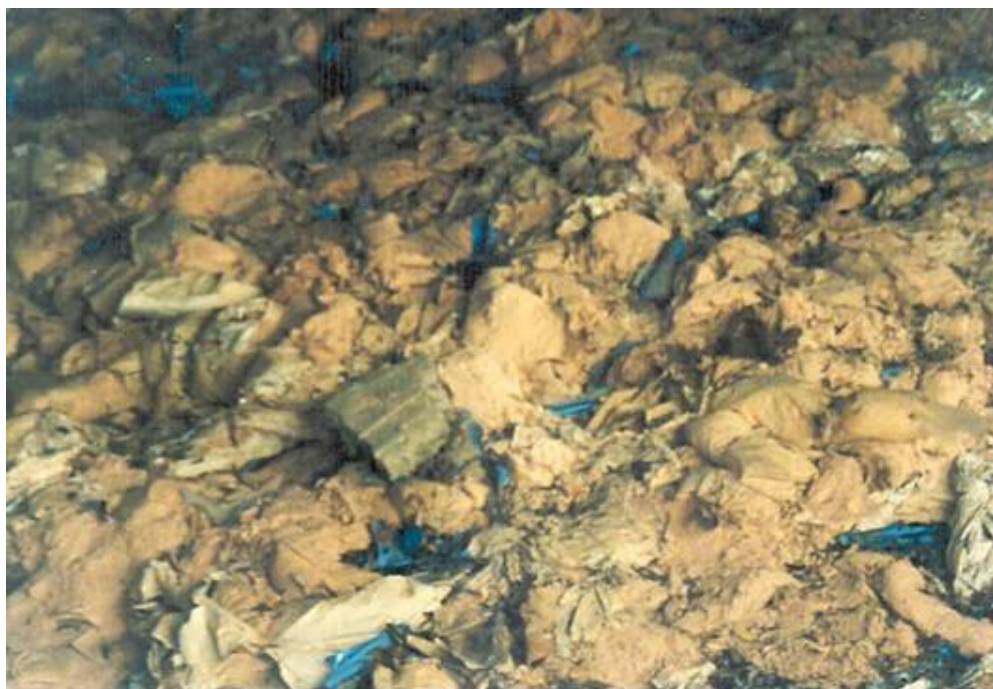
The stockpiles of chemicals at the site were identified from the remains of the worn out bags/packages which were labeled DDT powder. A detailed chemical characterization of the powder materials was not undertaken. To our knowledge, apart from DDT powder, no other chemicals were found at the site. Fig. 5 shows the bulk of DDT pesticides inside the store where the bags/packages have been worn out.

The quantity of pesticides at the site was estimated from the measurements of the storage facility which are: 14m long x 10m wide x 3m high. The effective height occupied with chemicals was 1.2m, which gives a gross volume of 168m<sup>3</sup> (pesticides and worn out bags). The observed quantity of DDT powder at Old Korogwe site seems to be comparable to that recorded in the 1997-98 inventories of obsolete pesticides undertaken by NEMC [5]. The same amount was also reported during the 2003 inventories and preparation of the Africa Stockpiles Programme (ASP) document by the Government of Tanzania [1]. However, a slight decrease in quantities could be attributed to probable continuous application in agricultural activities and wind dispersion. However, this study could not establish whether the obsolete stocks are still applied on farms.

Fig. 6 Stocks of DDT pesticides at Old Korogwe Site

- 4) The contaminated sites should be remediated to prevent further contamination of the land and water. However, a long term detailed study and investigation to establish levels of contamination needs to be conducted and needs to address the question of recovery.

- 5) Both remediation of the site and introduction of a site monitoring program need to be undertaken.
- 6) Develop criteria for contaminated site ranking for a country-wide study of contaminated sites.
