**VIKUGE PRELIMINARY SITE REPORT,
COAST REGION, TANZANIA**

Final Report

August 2004

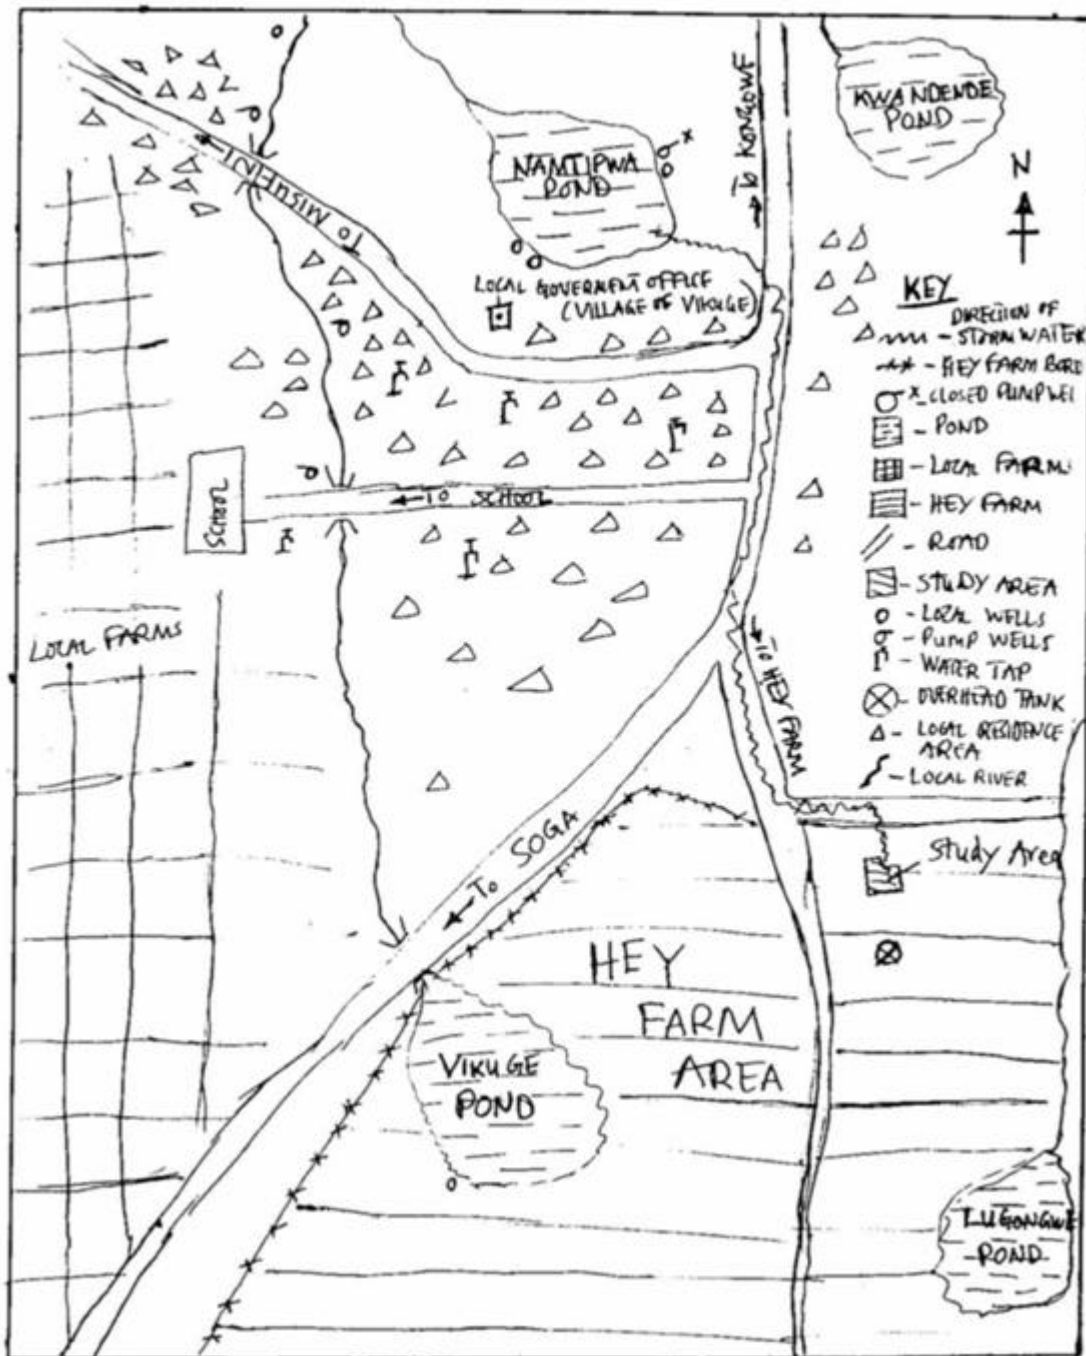
Fig 2.1 Resource map of Vikuge village

A small group of villagers, including Village leaders, members of the village environmental committee and elders were asked to describe the village area in terms of its general boundaries, available institutions, important infrastructure, natural habitats, and local usage of ground / surface waters, and locations of water boreholes. Where possible, distances were indicated on the map (Fig. 2.1).

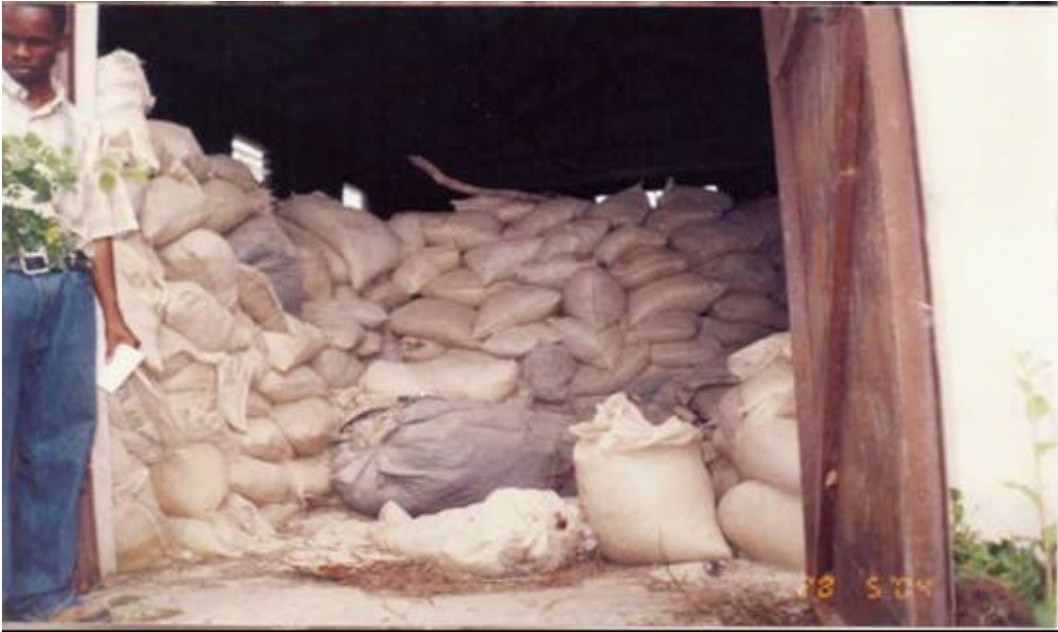
Plate 3: Stock of Pesticides in New store

In 1993 the shed collapsed, the pesticides therefore were exposed to direct sunlight, rain and other climatic variations. Slowly the bags started leaking contaminating soils as well as ground water. After years in 1996 with external assistance of the Government of Sweden (Sida), a special store was built, under supervision of the National Environment Management Council (NEMC), the Government of Tanzania repackage. All stocks (Plate 3) were then stored in that dedicated pesticide store, which is situated just 20 meters away from the original storage site.

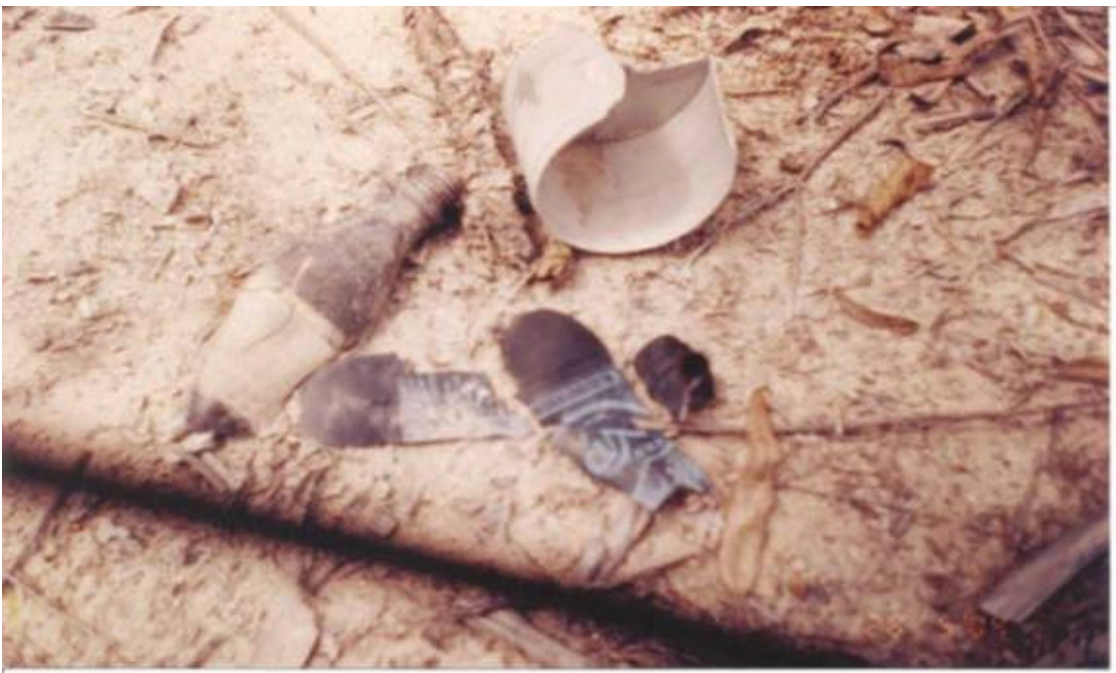
Ten years after the pesticides were repackaged, one can still smell DDT outside the new store and considerable environmental contamination can be observed. Dead insects are observed on the area and vegetation no longer grow on some patches where the bags once lay. Small pieces of pesticides containers (Plate 4) are scattered all over the place left in the area during re-packaging.

Plate 4: Pieces of pesticide containers

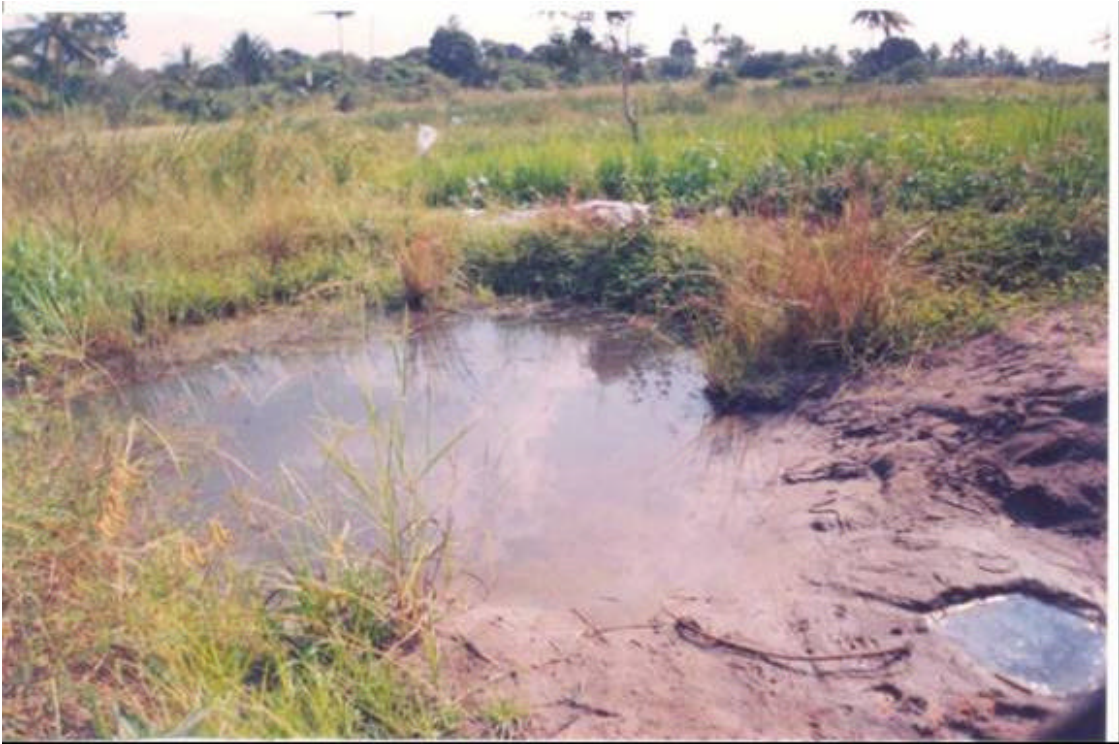
Due to costly and unreliable supply of tap water, the Villagers of Vikuge use hand dug wells, which are located within the Namtipwa stream and other streams located on the lower lands. As noted under section 3.5.2 (Topography) and section 3.5.4 (Hydrology) surface run off from the upland including the contaminated site draining towards the lower areas. This suggest that there is high probability of contamination to the streams and ponds. Also, at the Vikuge village, sanitation is such that all households use traditional pit latrines. Such drainage and high water table could contribute to the contamination of the surface water as well as ground water.

Plate 5: Local well located at Namtipwa stream

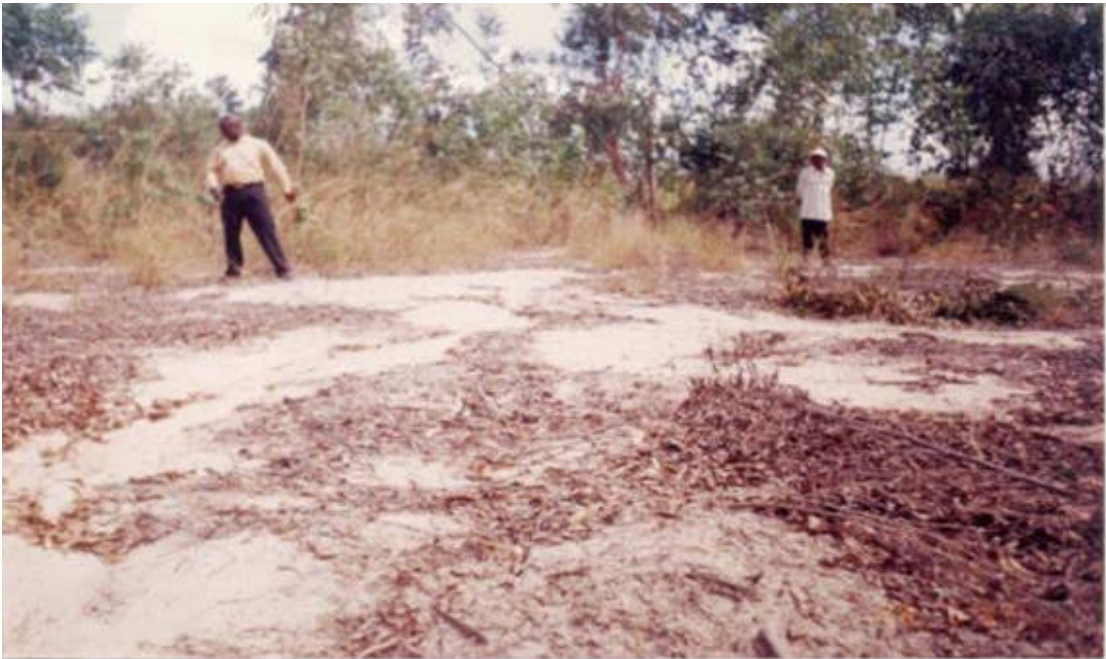
Vikuge area is characterised with scanty vegetation, which consist mainly of bush thicket mixed with annual herbs, thorns, deciduous shrubs, grasses, and some few evergreen exotic trees. Before the consignment was brought at Vikuge site, most of the indigenous trees and vegetations for a long time were already affected from the pressure of human activities such as grazing, farming (Sisal plantation) and fuel wood collection. The vegetation found at the contaminated site (the old store site, Plate 6 and new store, Plate 7) include the following types:

Plate 6: Old storage site

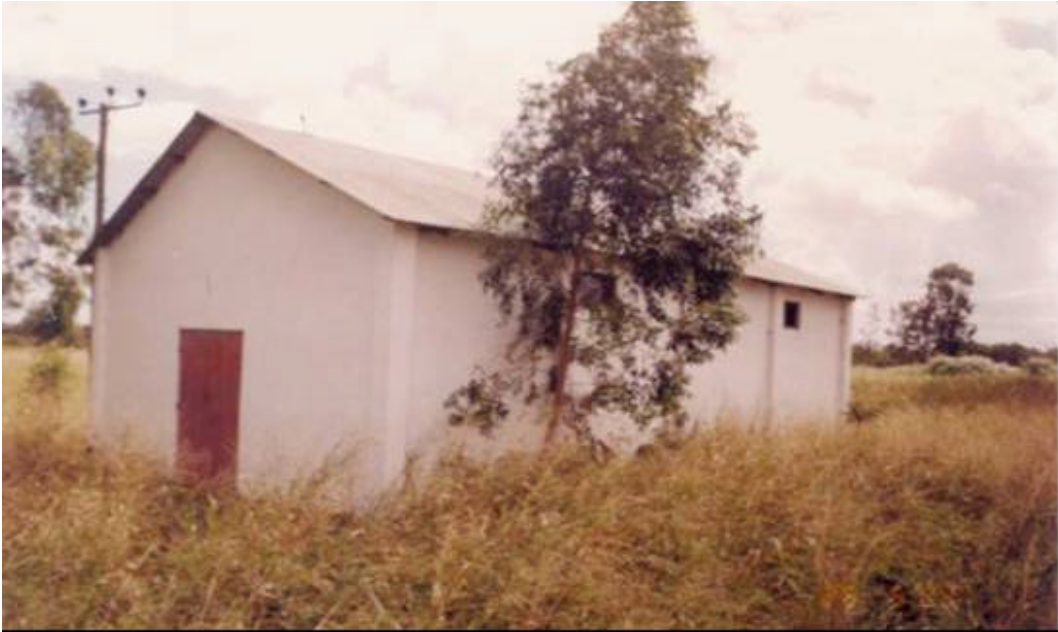
Plate 7: New storage site

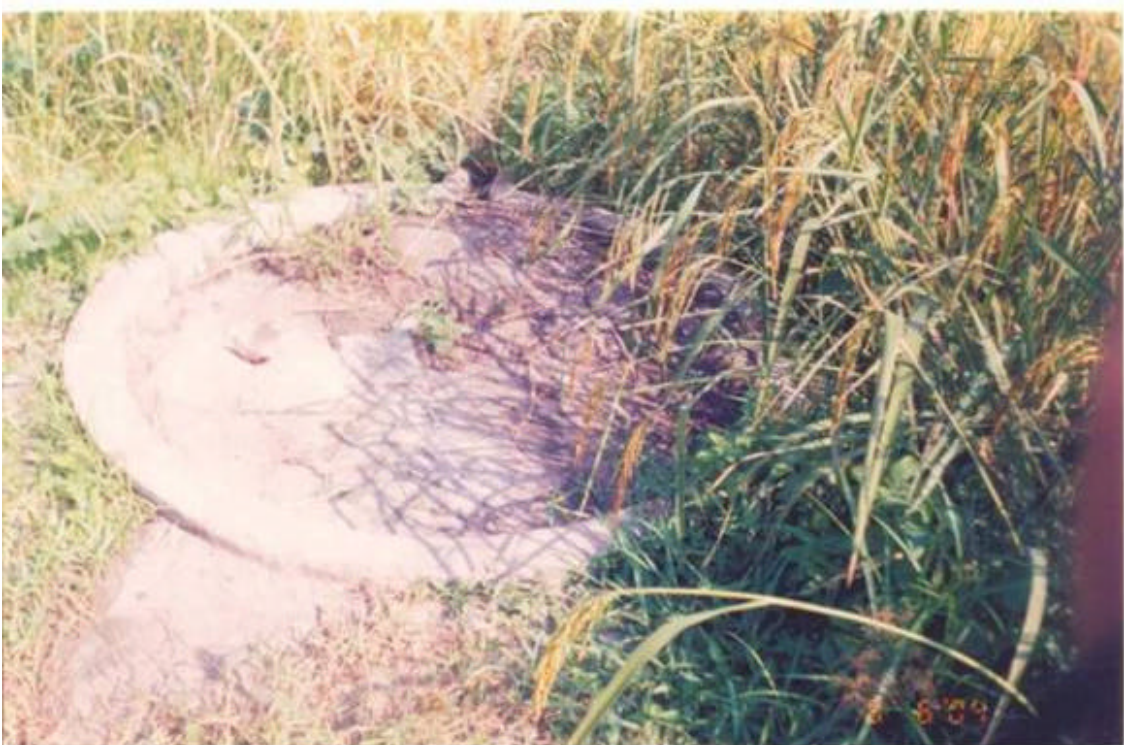
Plan International constructed 4 boreholes in Vikuge Village to provide the villagers with clean and safe water. The Village had a problem of clean and safe water for many years. Unfortunately water quality of one borehole, which was constructed on the edge of Namtipwa stream, was found undesirable for domestic and animal use and the borehole was sealed (Plate 8). The reasons for closing that borehole were not revealed to the study team.

Plate 8: Closed well

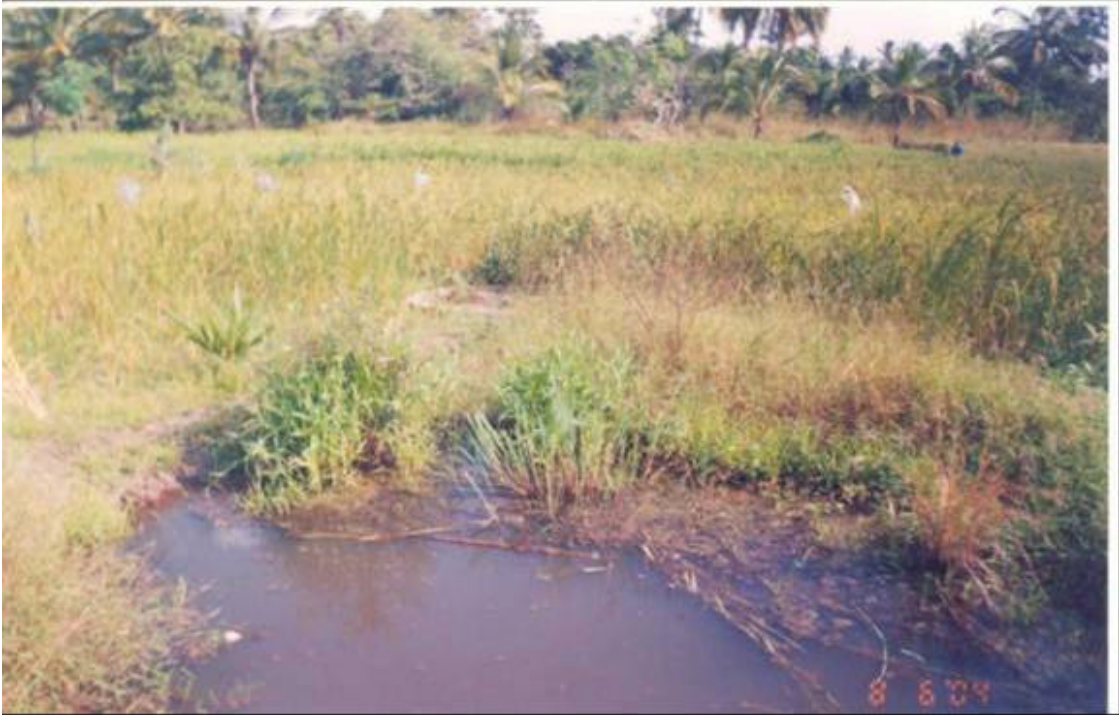
Plate 9: Closed well along side a local well
